INTRODUCTION

Photo 1: View of the Pulda House from the northwest.

The Pulda Farm is located at 300 Old Georges Road, North Brunswick Township, Middlesex County, New Jersey. It is situated on the south side of Old Georges Road at an intersection with Route 130. The 70 acre property extends from the road to the south all the way back to Farrington Lake. The house is situated on a slight rise set well back from the road, and the property consists of agricultural fields, some fallow fields, woodlands and the farm yard. A long gravel and dirt driveway provides access to the house and continues past the west side of the house to out buildings and back to fields and wooded areas beyond. To the east side of the house down a slope is a fallow orchard, which is clear in historic aerial photographs.

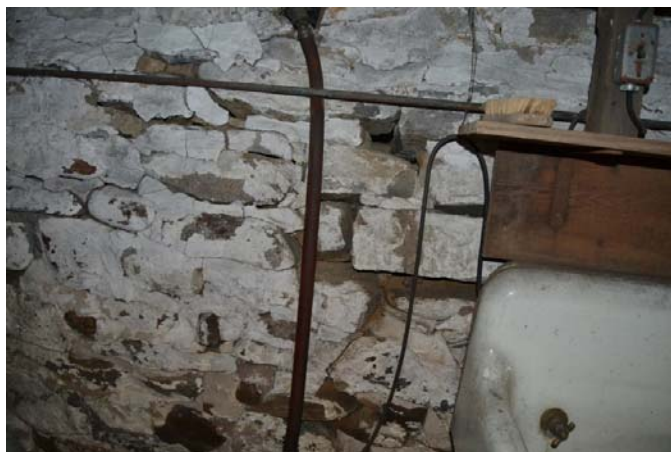
The rubble stone foundation of the two story section is, for the most part, solid with the exception of a section of the rear wall to the east of the bulkhead entry. The wall here is completely failing, possibly due to the laundry sink ejector pump, which might have been expelling water on the ground directly outside this wall, overtime deteriorating the mortar holding it together. The interior brick piers at the full basement are in good condition.

Photo 15: Failing portion of the foundation at the rear wall of the main section.

- Provide new concrete slab at basement.
- Reconstruct failing foundation wall at rear of basement on new footing. Approximately 10'-6".
- Provide spread footing and steel column beneath west end of east-west summer beam in basement where it bears on the basement window header.
- Reconstruct foundation at front of one and one-half story section on new footing. Approximately 8'.
- Reconstruct two chimneys at two-story section to match historic from approximately 4-ft. above the attic floor level up. Do not re-plaster at exterior. Provide new flashing and cap.

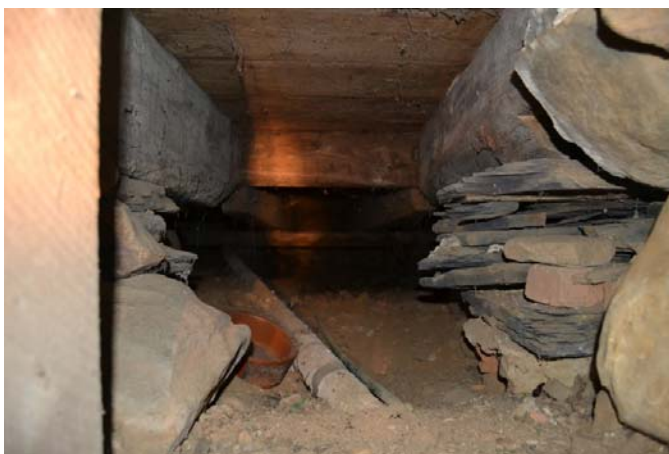
The foundation at the small east section is also in fairly good condition, with the exception of the north side where a portion of the wall is failing because of prolonged water infiltration due to previously failing gutters. Some of the interior pier conditions are also suspect and should be reinforced or replaced.

Photo 16: View into the crawl space showing one of the suspect piers at right.

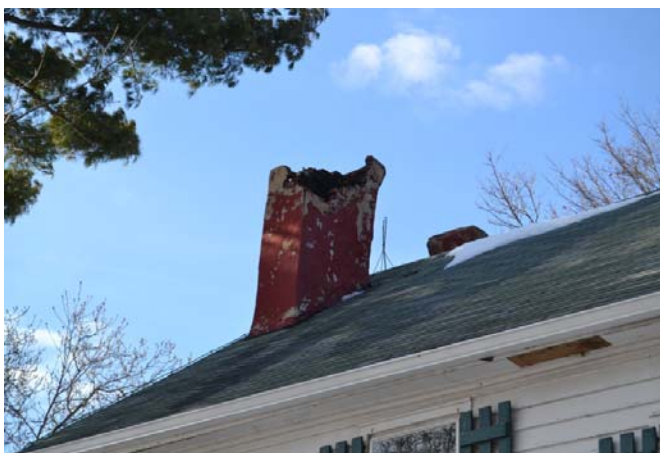
There are two brick chimneys at the west end of the main section. The chimneys are in poor condition with the south chimney having lost a significant amount of brick. At the one and one-half story section, the chimney has been reconstructed and is in good condition.

Photo 17: Failing south chimney at the main section of the house.

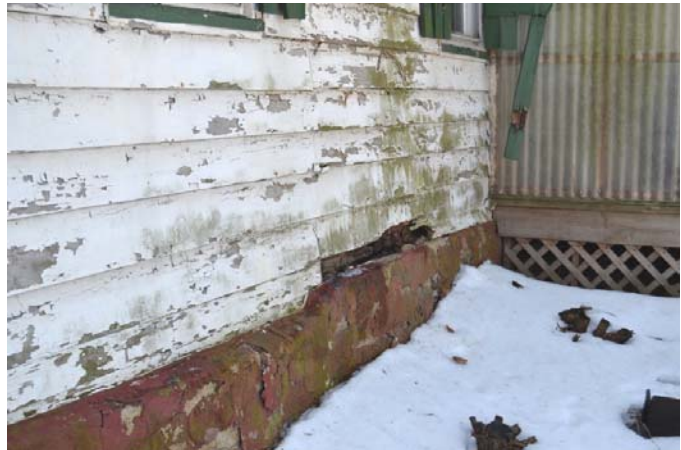
A section of the sill plate at the front of the one and one-half story section is deteriorated where the vulnerability of the sill plate is exacerbated because the masonry foundation projects in front of the frame wall. This creates the potential for water to collect at this point and to be directed back towards the wood finishes and framing. This foundation condition can be found throughout the building. Upon inspection of the crawl-space, it was also noted that the east sill plate appears to be in poor condition with the floor joists in the kitchen not fully engaged with the sill plate. At the upper level, a section of the rafter plate at the front of the house exhibits advanced deterioration. This could be the result of the same failure which caused the damage to the sill plate below and has been corrected, at least on a temporary basis.

Photo 18: Front of the one and one-half story section at the foundation showing area of deteriorated siding and sill plate. This was likely exacerbated by failed gutters which were recently replaced.

- General: Given the intact character of much of the historic timber-frame, repairs should be undertaken using traditional joinery and wood species.
- Repair sill plate at front of one and one-half story section. Assume 6-ft. repair. Replace damaged siding.

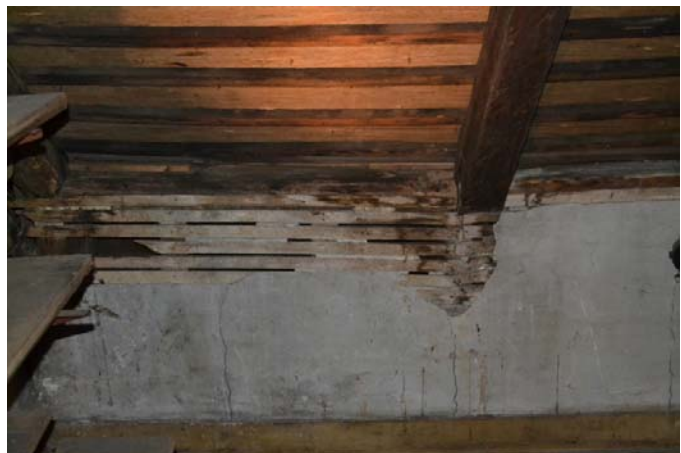
Photo 19: Area of damaged rafter plate at the front of the one and one-half story section.

- Repair rafter plate at front of one and one-half story section. Approximately 6-ft. repair.
- Remove siding and plaster at the rear east end of two-story section. (Photo XX) Evaluate framing and make repairs. Remove and reinstall brick nogging as necessary. Provide vapor barrier. Replace siding and flashing at exterior and plaster and finishes at interior.

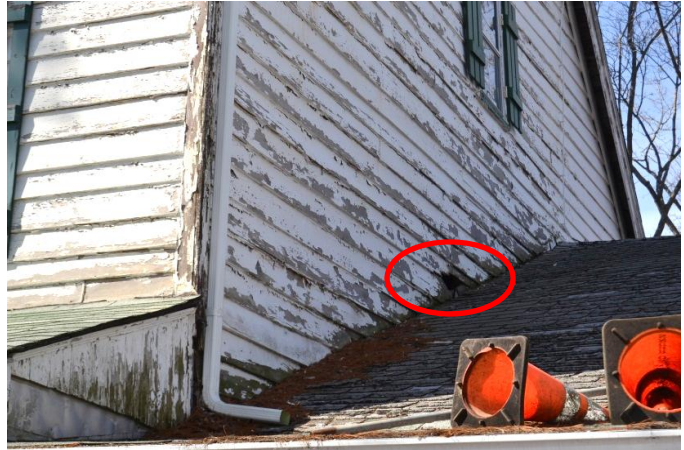
There is also significant damage of the siding, interior finishes and presumably structural members at the rear east wall of the main section above the roof of the one and one-half story section. The damage apparent at the exterior has resulted in failing finishes and bulging plaster at the interior above the main stair, which indicates a potentially serious structural problem. At the top portion of this, the tie beam running just below the attic window is severely damaged and requires repair. It appears that this damage occurred prior to the installation of the current siding.

Photo 20: This area of damaged siding the east end of the main section where it meets the roof of the one and one-half story section has resulted in structural problems with this wall.

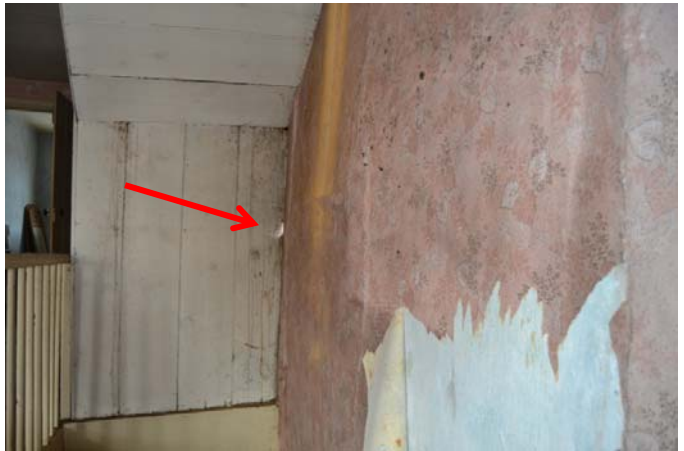
Photo 21: The interior of the area shown in Photo 19 above. Note daylight is visible at the far end of the plaster wall which is bulging inward.

- Replace plaster at the two-story section stair hall east wall from the bottom stair up to the ceiling and the ceiling itself in the second floor hall.
