INTRODUCTION

Photo 1: View of the Pulda House from the northwest.

The Pulda Farm is located at 300 Old Georges Road, North Brunswick Township, Middlesex County, New Jersey. It is situated on the south side of Old Georges Road at an intersection with Route 130. The 70 acre property extends from the road to the south all the way back to Farrington Lake. The house is situated on a slight rise set well back from the road, and the property consists of agricultural fields, some fallow fields, woodlands and the farm yard. A long gravel and dirt driveway provides access to the house and continues past the west side of the house to out buildings and back to fields and wooded areas beyond. To the east side of the house down a slope is a fallow orchard, which is clear in historic aerial photographs.

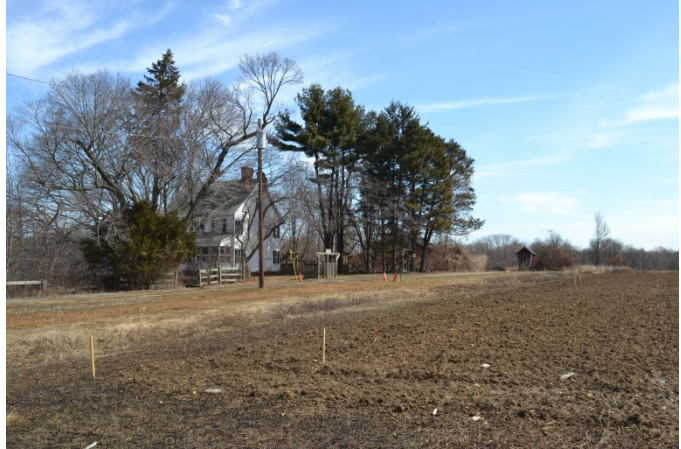
Photo 2: View of the farm from the northwest. The property, fairly level here, drops off sharply to the east from the house and driveway.

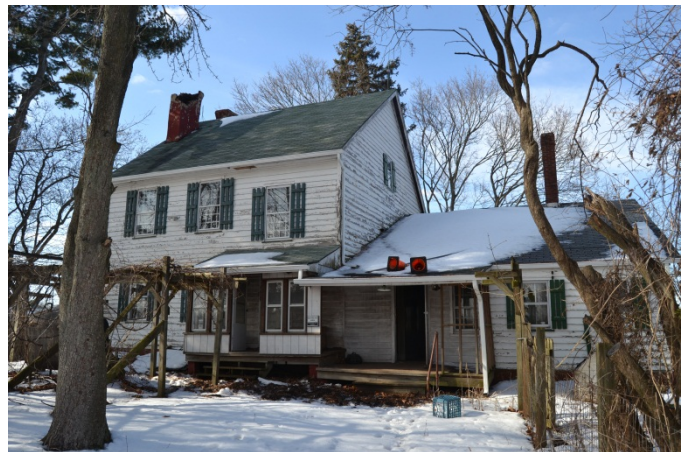
Photo 3: View of the rear of the Pulda House.

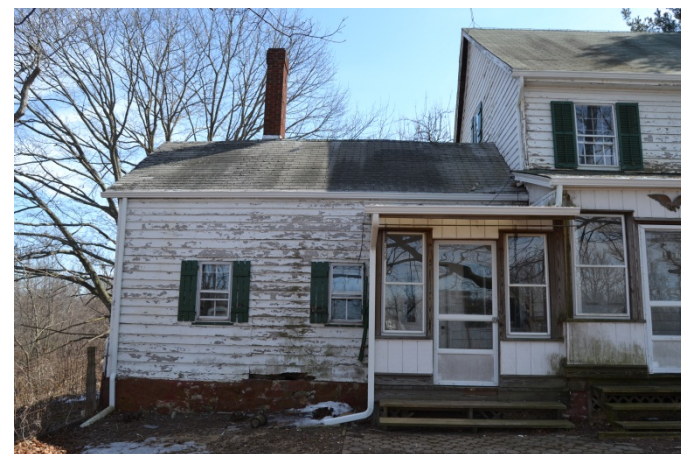
Photo 3: View of the front of the early one and one-half story section.

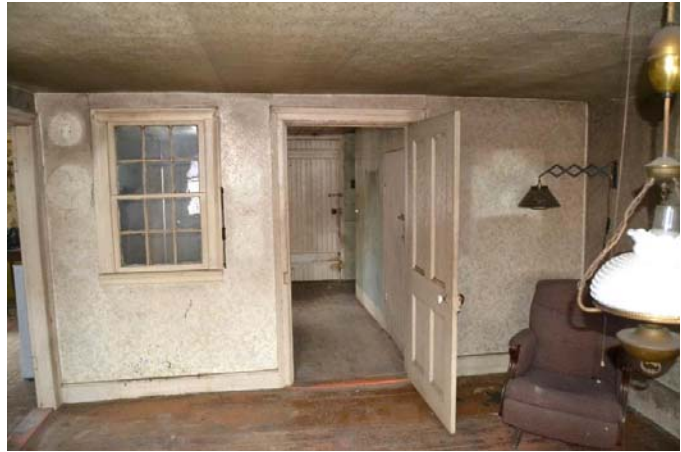
Photo 4: View to the rear of the parlor in the one and one-half story section looking into an area that was original a porch. The wall shown here is the original exterior rear wall.

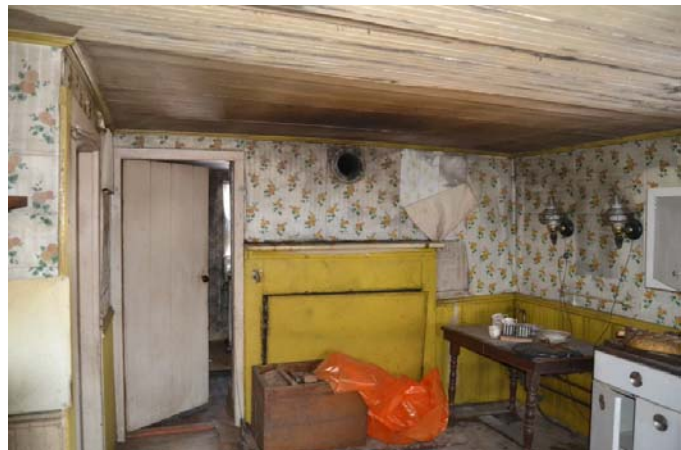
Photo 5: View north in the kitchen showing a fireplace. There is evidence of a large cooking range in front of the fireplace. The left side of the fireplace seems to roughly mark the original end of the building.

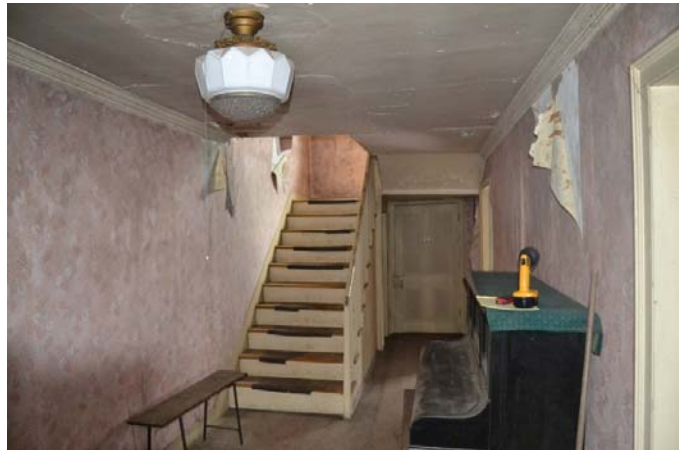
Photo 7: View south in stair hall of the two-story section.

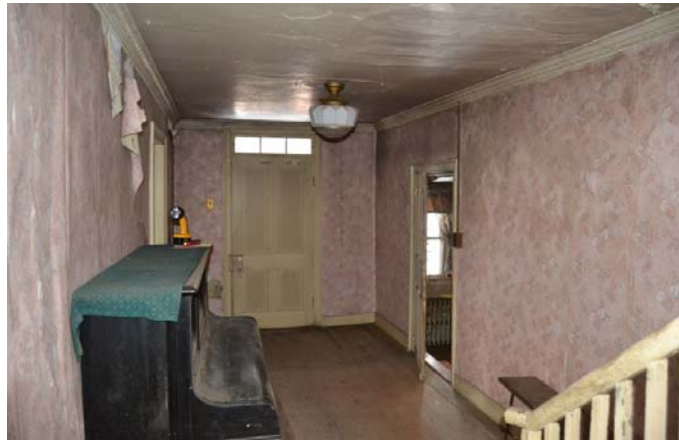
Photo 8: View north stair hall of the two-story section. The door to the right enters down in to the parlor of the one and one-half story section.

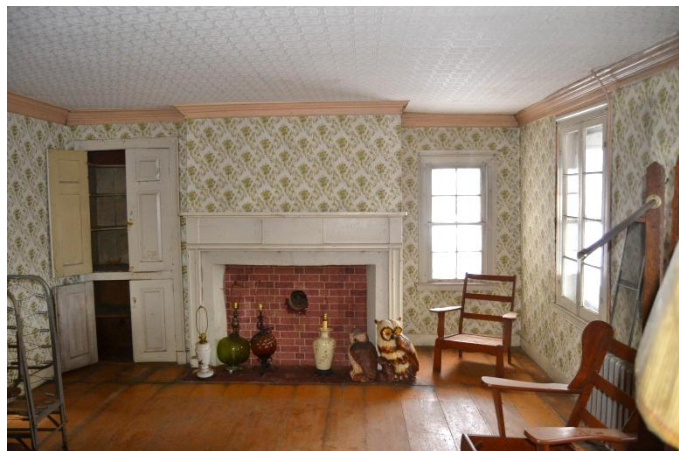
Photo 6: View of the west wall in the front parlor of the two-story section of the house.

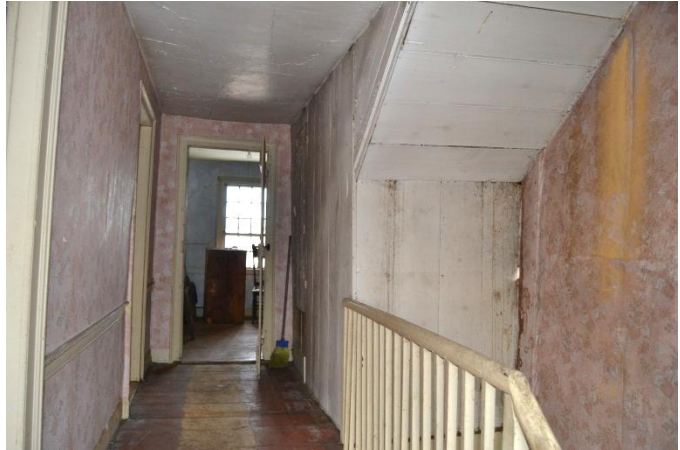
Photo 7: View north in the second floor hall showing the small room at the front of the hall.

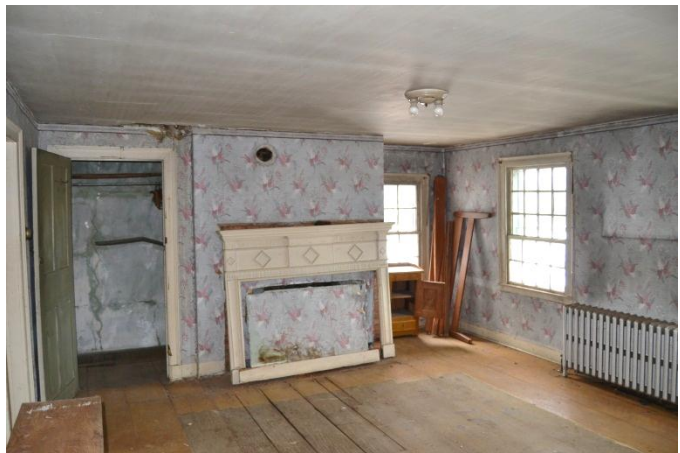
Photo 8: View west in the front chamber. Note the four-over-four sash at the west wall and twelve-over-eight sash at the north.

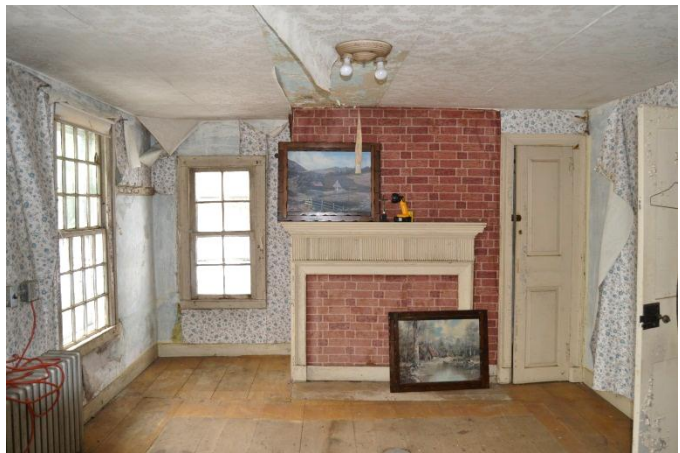
Photo 9: View of the west wall in the rear chamber, second floor. Note the larger twelve-over-twelve sash at the rear (south) wall.

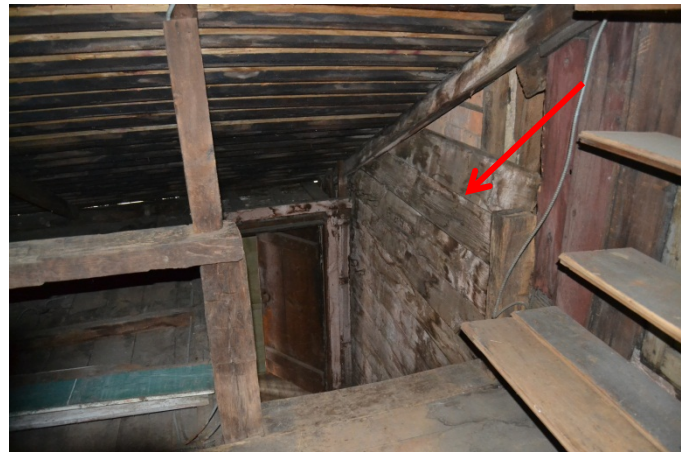
Photo 10: Clapboard siding within the stair to the attic of the one and one-half story section, showing that this rear section was enclosed after the two-story section was constructed.

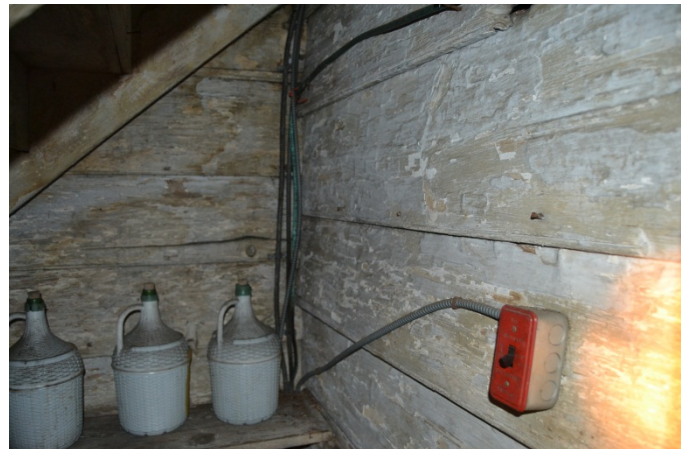
Photo 14: Clapboard around the interior bulkhead door entrance to the basement.
